FUNGUS: Functional Assessment of Geomechanical and Fluidic Properties of an MgO Drift Seal – 25194

Tilman Fischer¹, Nina Müller-Hoeppel¹, Thomas Wilsnack², Uwe Glaubach² and Johannes Kulenkampff³

¹BGE TECHNOLOGY GmbH

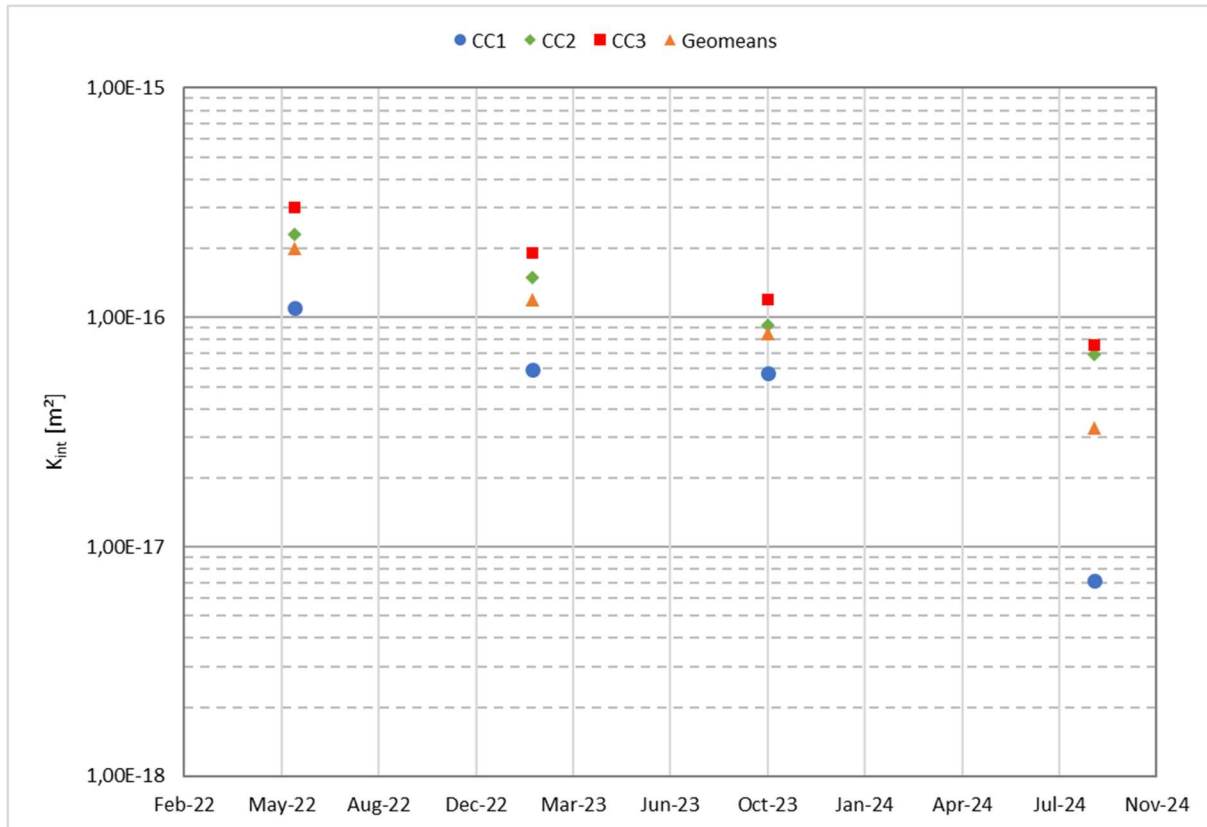
The values in Table 1 already show a clear trend. In all cases, a reduction of the permeability was observed. To show this trend even more clearly, a graphical illustration of the measured values can be found in Figure 5. It suggests a linear decrease of the logarithmical scaled permeability of the individual group of measurements with time. Only the value belonging to the measurement of MC1 in October 2023 falls out a little, potentially indicating the last phase before the permeability reduction related to pressure build-up in the range of a zero effective hydraulic pressure (i.e. the fluid pressure criterion is fulfilled [4]). However, it needs to be clarified that the permeability values in Table 1 are values for this specific concrete structure and cannot be compared directly with results from measurements in drift seals. Even though the contact zone only describes an area with a thickness of 2 mm, it has a significantly greater influence on the half-dam described in this paper than in a full drift seal.

In order to be able to better assess the influence of the contact zone on the integral permeability of the dam and to be able to better classify the contact zone individually, the permeability of the contact zone was determined. Here, as with the integral permeability of the half-dam, a decrease of the permeability was observed. The permeability of the contact zone itself decreased from the range of 1.1E-14 m² to 2.0E-15 m² in June 2022 to the range of 2.2E-15 m² to 1.0E-16 m² in September 2024.

Figure 5 – Graphical display of the development of the integral permeability of the half-dam with time.

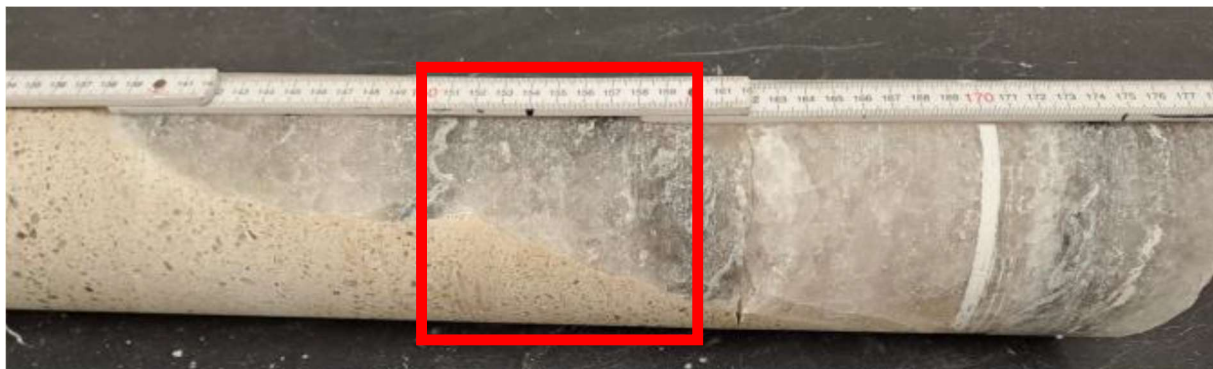
Figure 6 shows a drill core from the borehole B20, which penetrates through the half-dam and ends in the wall of the drift. Figure 7 shows a section of this core sample investigated by CT. The tight contact zone at the wall has exemplarily visually confirmed what was already concluded from the results of the negligible pressure build-up in the HCs during the in situ test series.

Figure 6 – Core sample of the contact area between concrete and formation obtained from borehole B20.

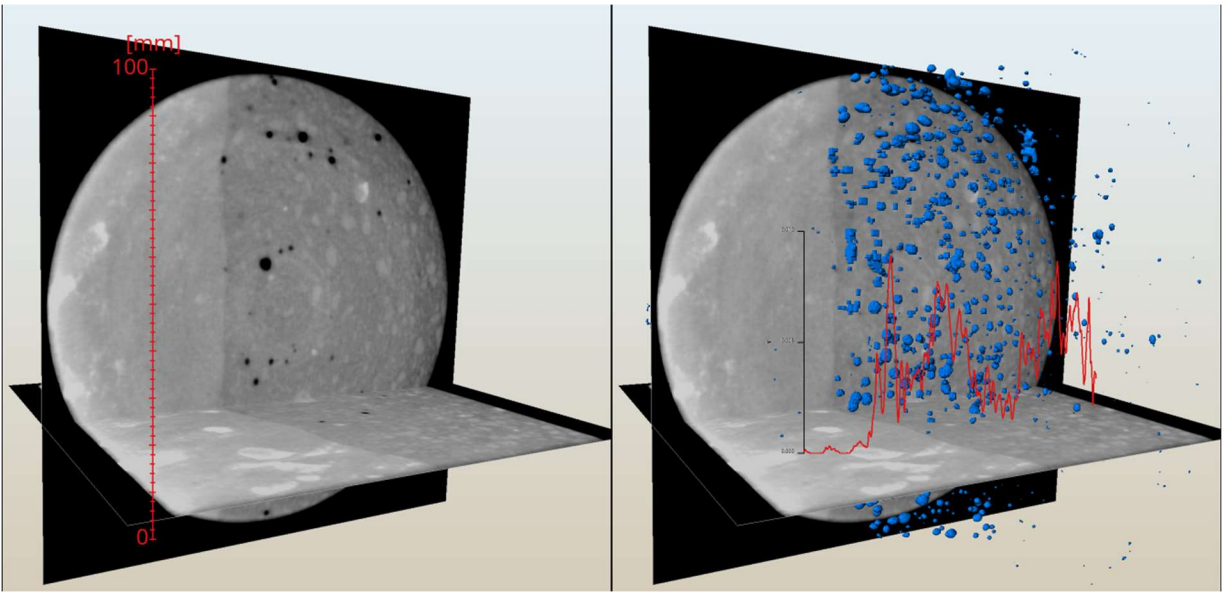
Figure 7 - CT image of the red marked section (Figure 6) of core sample from borehole B20 (left). CT image pointing out the air filled pores in a 3D system (blue) and the derived porosity profile (right). Voxel size of 44.9 μm .

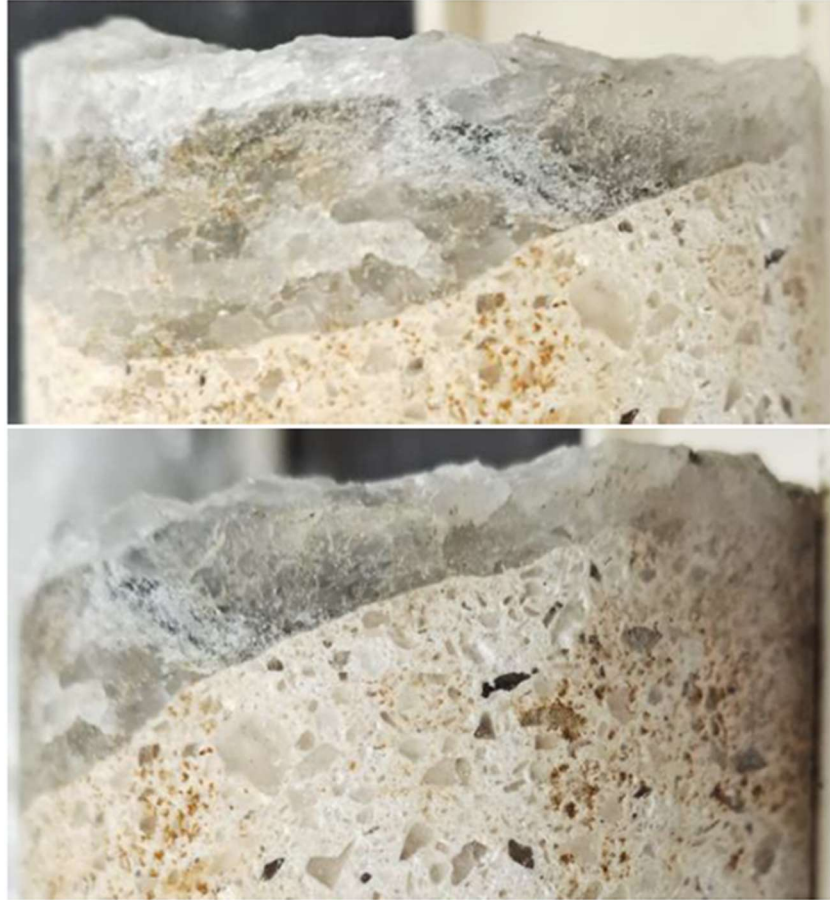
In contrast to the contact zone at the wall, where the majority of the core samples showed tight bonding of the contact zone, the bonding quality of the contact zone in the floor varies, evidently. Figure 8 shows a photo of the contact zone at the floor from a core sample of B31. This borehole was drilled vertically through the half dam into the floor of the drift. Regarding Figure 8 a good bond between salt and concrete can already be assumed, since no gaps can be seen. Furthermore, the breakage of the core took place in the salt section and not at interface, suggesting a tight mechanical contact. The salt aggregate can be clearly identified in the MgO-concrete. Furthermore a fairly homogeneous distribution of the aggregate can also be observed. Figure 9 displays the associated CT images of the core sample from borehole B31.

Figure 8 – Core sample of the contact area between concrete and formation obtained from borehole B31.

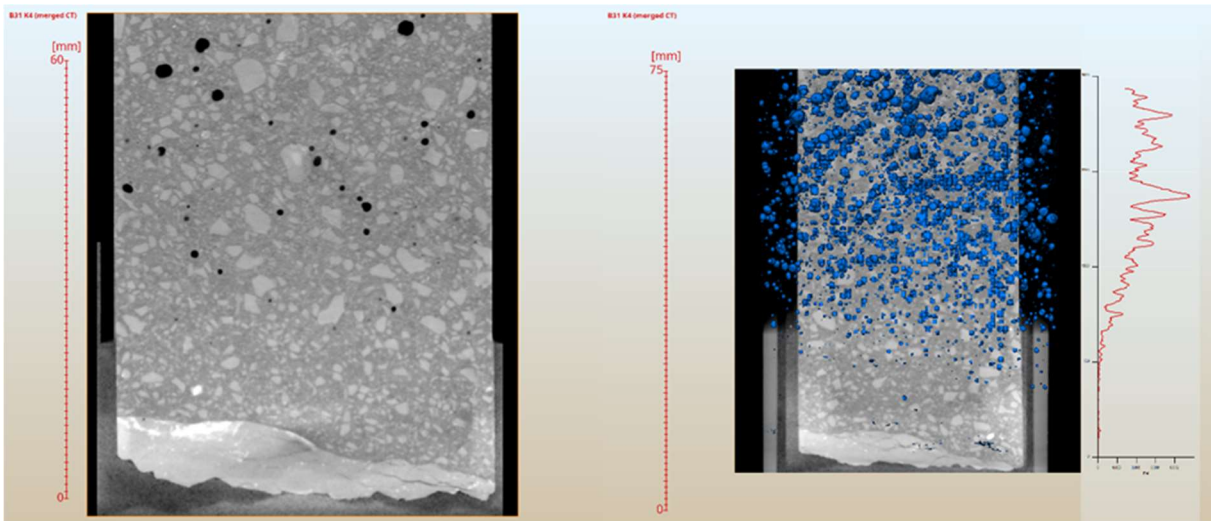
Figure 9 - CT image of the core sample displayed in Figure 8 (left). – CT image of the core sample displayed in Figure 8 pointing out the air filled pores in a 3D system (blue) and the derived porosity profile (right). Voxel size of 23.7 μm .

Figure 9 (left) shows the CT image in general, the top being the MgO-concrete and just a bit of the salt at the bottom. The darker the colors in the figure, the lower the density. As the concrete is dry after hydration, the black dots are identified to be air filled pores. Figure 9 (right) shows the distribution of the air-filled pores in a 3D system and the porosity profile. As it can be seen in both figures, no air filled pores can be

identified at the interface. Furthermore, no cavities or gaps between the salt and the concrete are observed. Again it may be concluded that the bond between the salt and the MgO-concrete is quite good. As it was already mentioned before, the core broke near the contact zone in the salt. Some fractures and fissures can be identified on the far bottom of the CT images. The width of these fissure is below 0.1 mm. Supposedly, these fissures are a result of the breakage of the core in this region.

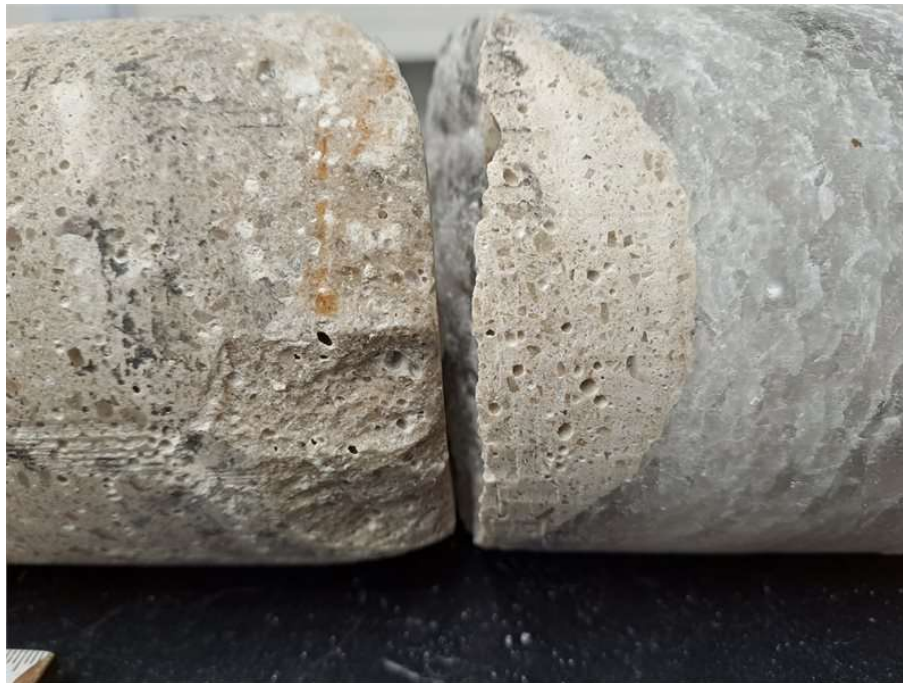
The second core, penetrating the contact zone on the floor of the drift, suitable to take CT images was obtained from the borehole B23. The B23 was drilled slightly slanted as it can be surmised based on Figure 2. Either during drilling or when retrieving the core from the borehole, the core broke at the contact zone between concrete and salt formation. However, the fracture does not follow the interface (Figure 10) but runs through salt and concrete. This might be an indicator that the connection between the MgO-concrete and the salt formation is of a good and strong quality. Although the drill core is not quite ideal, CT images were taken which can be found in the Figure 11.

Figure 10 – Core sample of the contact zone between concrete and formation obtained from borehole B23.

In Figure 10 and Figure 11, air filled pores can be identified in the core sample from borehole B23. However, they are not directly located at the interface between salt and MgO-concrete. Fine cracks can be seen in the salt, which run towards the concrete. The origin of these fissures is difficult to name, they could be caused either by the excavation of the drift or by the breakage of the core sample. Although the latter explanation seems to be more plausible it has to be taken into account that the contact zone in the floor seems to be the main pathway with respect to the results of the hydraulic measurements in situ.

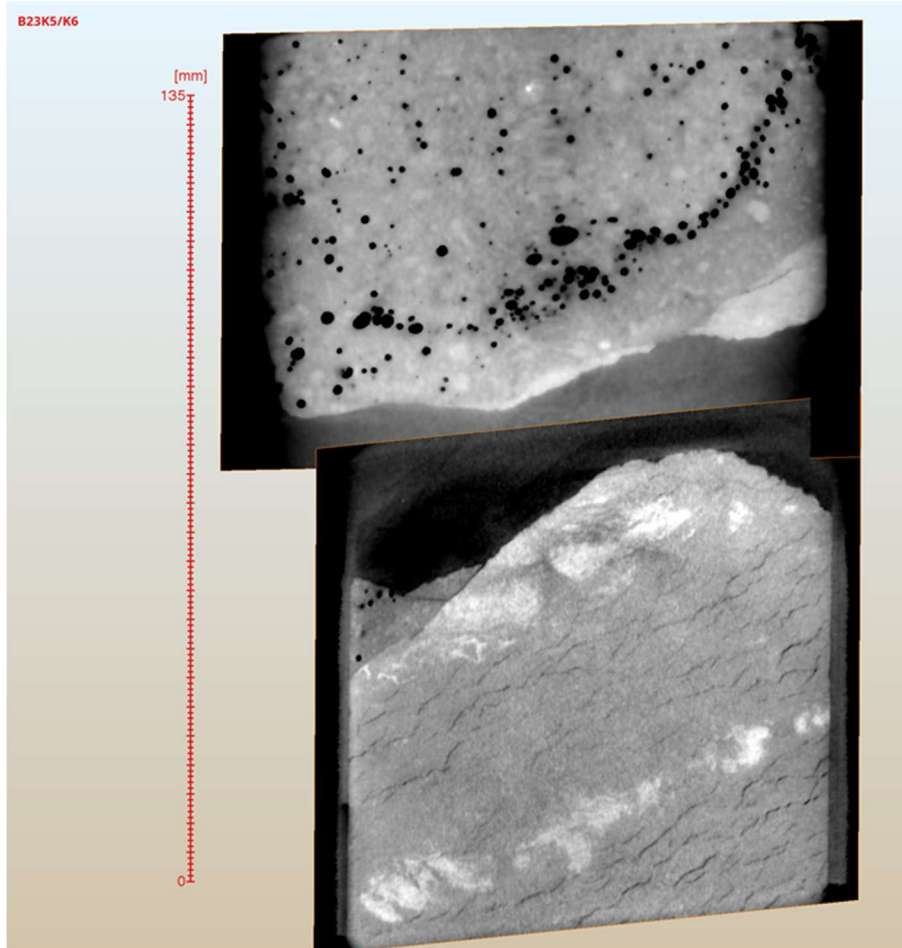
Figure 11 – CT image of the core samples displayed in Figure 10.
