FUNGUS: Functional Assessment of Geomechanical and Fluidic Properties of an MgO Drift Seal – 25194

Tilman Fischer¹, Nina Müller-Hoeppel¹, Thomas Wilsnack², Uwe Glaubach² and Johannes Kulenkampff³

¹BGE TECHNOLOGY GmbH

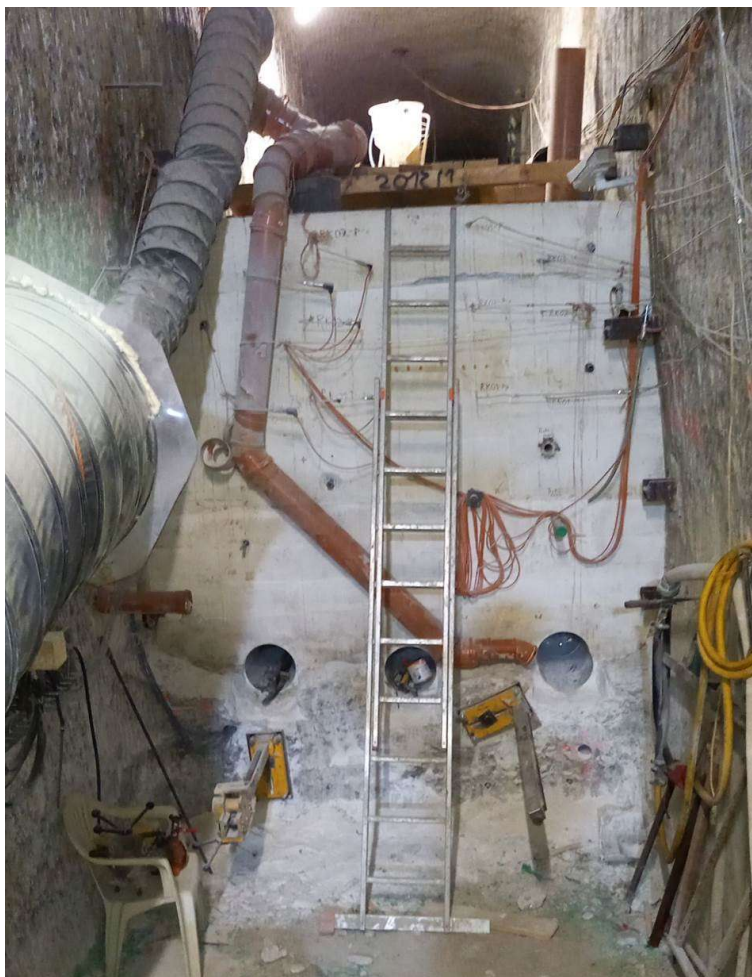
Figure 1 – Front view of the half dam at the end of the STROEFUN-Project [2].

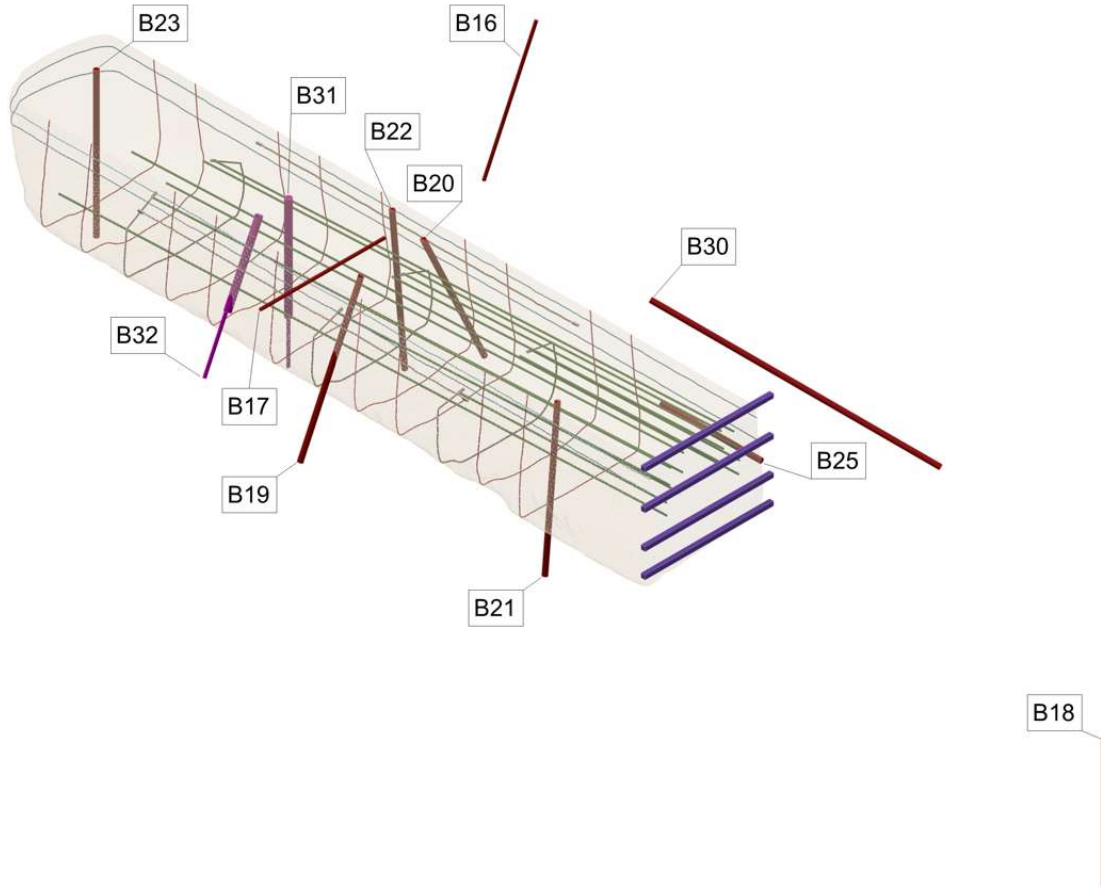
To give an idea about the work done during the first drilling campaign, Figure 2 shows the boreholes drilled during this phase. As the figure shows, the boreholes are penetrating the formation, the sealing structure or both. Figure 2 already implies different lengths, directions and diameters that are attributable to the different reasons for drilling the boreholes. During drilling through the sealing structure, a special challenge represented the installation of mechanical monitoring devices within the concrete element. Two boreholes (B31 and B32) were drilled in order to replace defect devices without damaging neither the measuring system nor the sealing structure itself by the drilling activities.

Figure 2 – Display of the boreholes drilled during the first drilling campaign of the FUNGUS-Project.

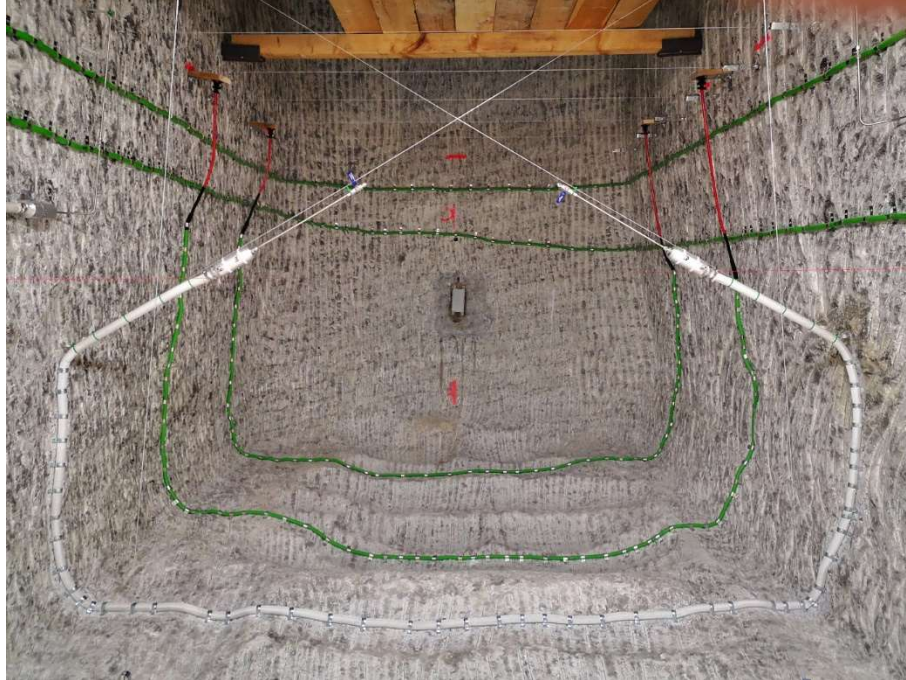
Before the concreting of the sealing structure, inflatable hoses were installed at the contour of the drift. These hoses are referred to as test chambers (TC), see Figure 3. These test chambers are either used for pressurisation or for pressure monitoring. If a chamber is pressurised, it is referred to as a pressure chamber (PC). If it is used for monitoring purposes, it is referred to as a monitoring chamber (MC).

Figure 3 - Installed test chamber 3 (white hose).

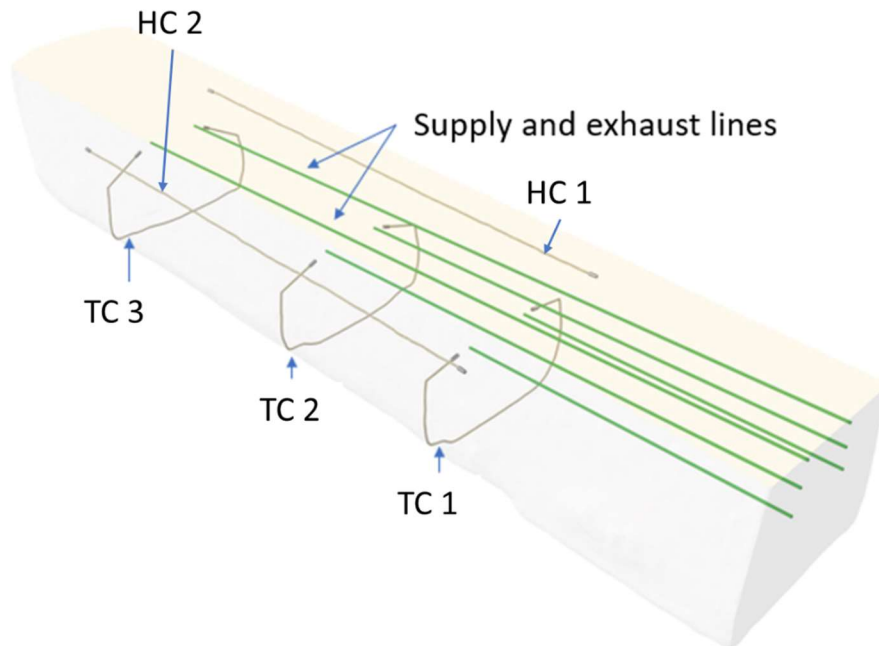
Due to the half-dam structure besides the TCs two horizontal test chambers (HC) are necessary to characterise the hydraulic system completely, in order to catch all outflows when summing up inflows and outflows on different pathways, correctly. An outline of the installation can be found in Figure 4. During the concreting of the dam, the TCs and HCs are pressurised. By relieving the pressure after the setting of the concrete, cavities are created for later testing.

Figure 4 - Illustration of the installation of the test chambers.
